EVALUATION OF MATURITY AND PULSE VELOCITY
MEASUREMENTS FOR PCC TRAFFIC OPENING DECISIONS

March, 1998

Iowa DOT Project HR-380

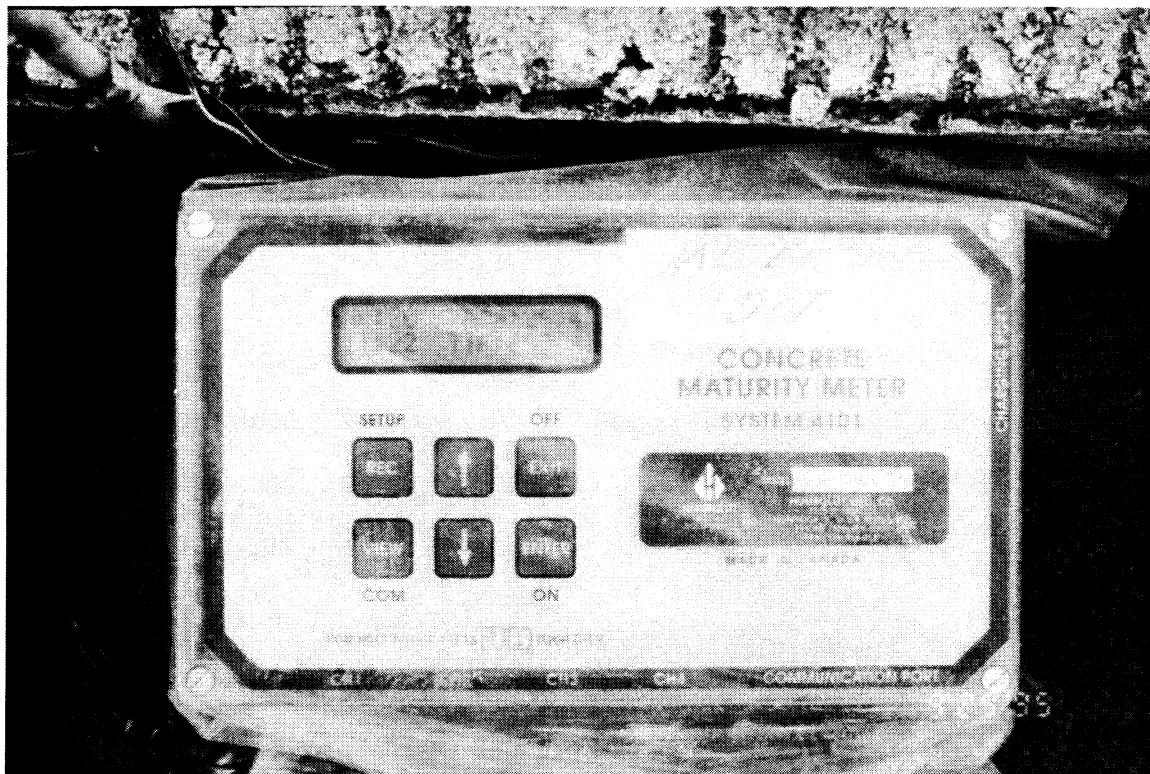
Figure 3, Humbolt Model H-2680, System 4101 Maturity Recorder devices were utilized for this project. Each device came with a handy carrying case, thermocouple connectors, and cabling for downloading. The device is connected to the pavement by a simple two-pole connector and "T" type thermocouple wire. One end of the wire is attached to the connector and the other is stripped approximately 1 in. (25 mm) to allow for twisting of the metal wire ends. The twisted end of the wire was positioned on a wood dowel for the desired depth of measurement. The dowel is then inserted into the concrete to measure temperatures at a 1-in. (25 mm) and 3.5 in. (87-mm) depth. The dowel is illustrated in Figure 4.

Maturity meters selected for this project were the Model H-2680, System 4101, manufactured by Humbolt Manufacturing Co. This device provides the potential for monitoring four channels or thermocouples simultaneously. Each meter can be programmed to begin recording at a user specified time, sample at a specified time interval, record time and temperature, and calculate maturity relationships in terms of time/temperature or equivalent age. It also provided the storage capacity for data of 365 days of recording and could be downloaded to most popular computer spreadsheets. It was chosen for its programming and recording abilities, number of channels and download capabilities. Figure 3 shows an example of the devices used in this project. Four such

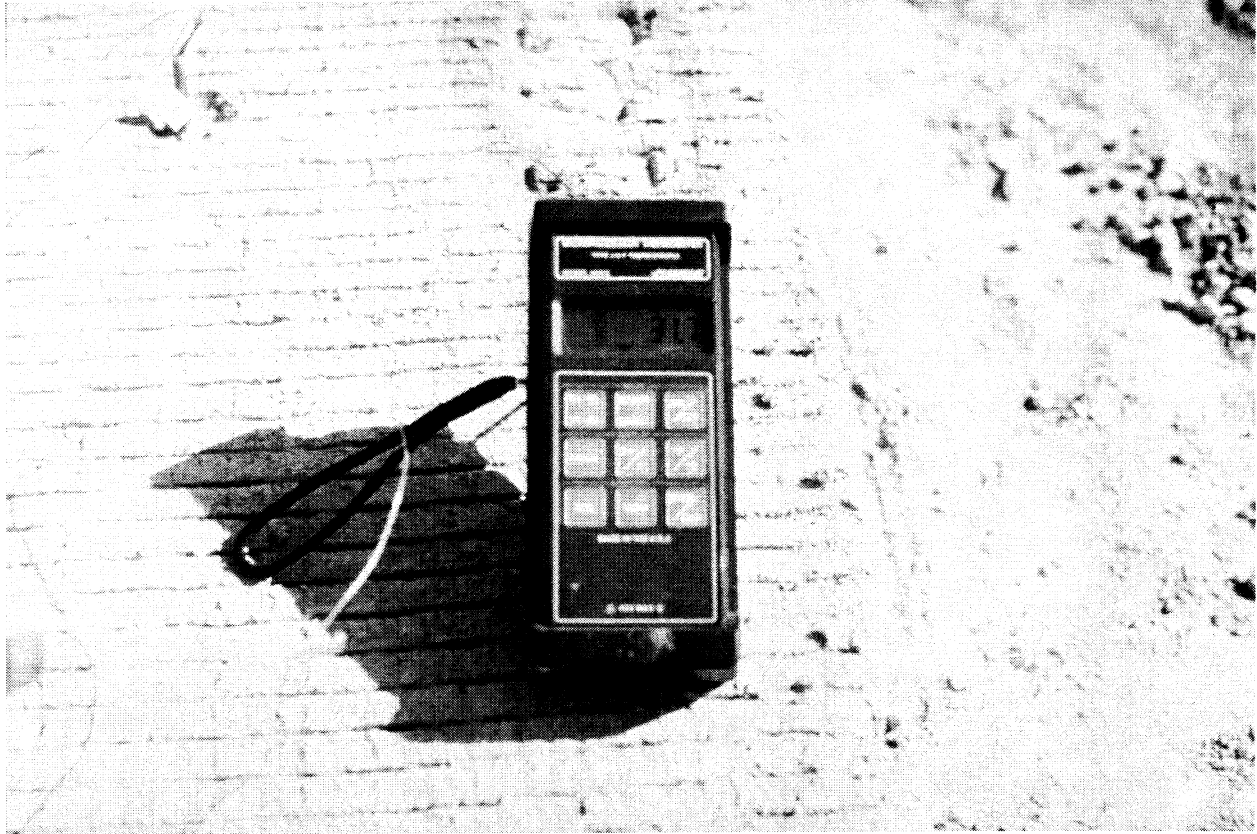
Figure 5, Omega Industries Digital Thermometer

Maturity temperatures were also measured with the use of digital thermometers manufactured by Omega Industries. These devices came in two models, the HH-23 and HH-25. An example of these devices is shown in Figure 5. They utilized the same type "T" thermocouple wire and connectors as used with the recording maturity meters. In the case of the Model HH-25 one thermocouple may be connected and evaluated. The Model HH-23 utilizes two connectors and can evaluate each thermocouple output or the differences between outputs. This unit also is equipped with an adapter that allows for the connection of six

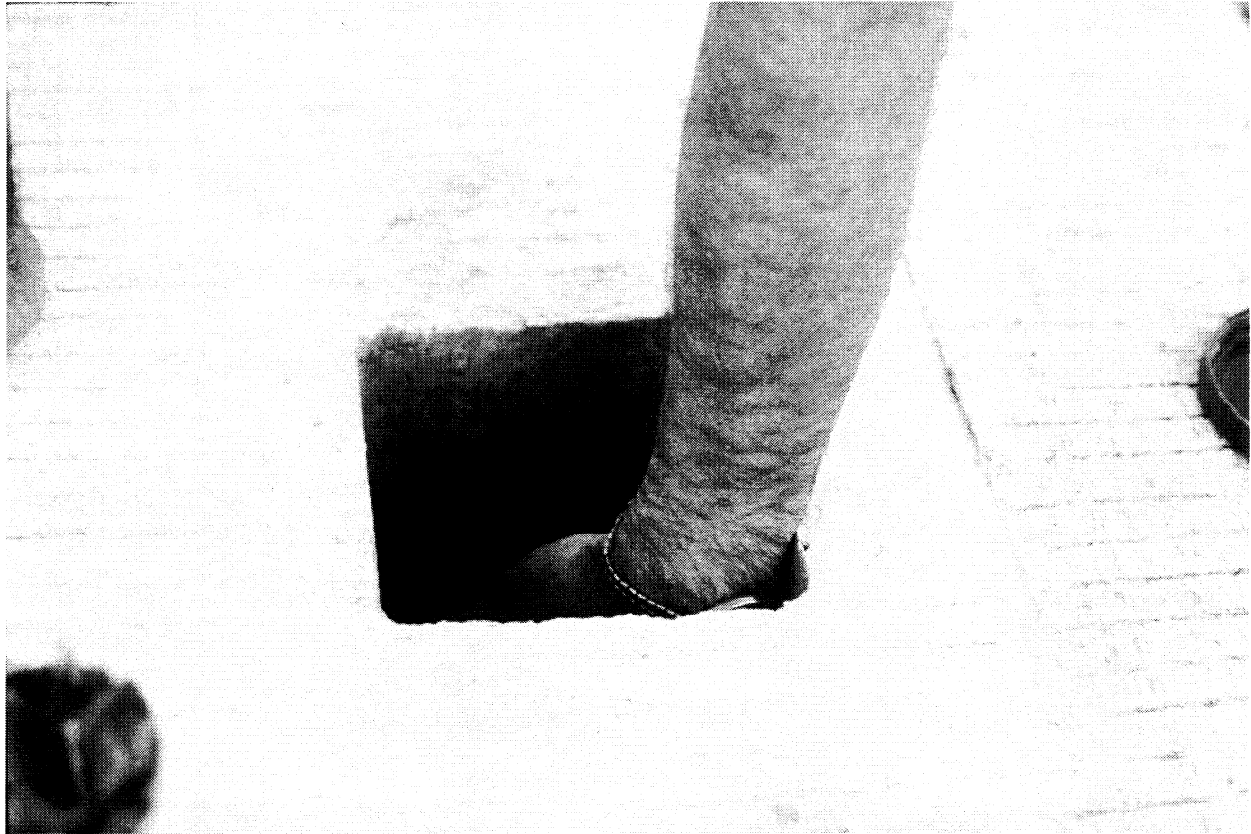
Figure 12 Pulse Velocity Test Concrete Removal Methods

removal of concrete from the interior of the test hole by use of a trowel or hands as shown in Figure 12. Tubing was removed upon removal of the concrete from the pavement in each test hole.

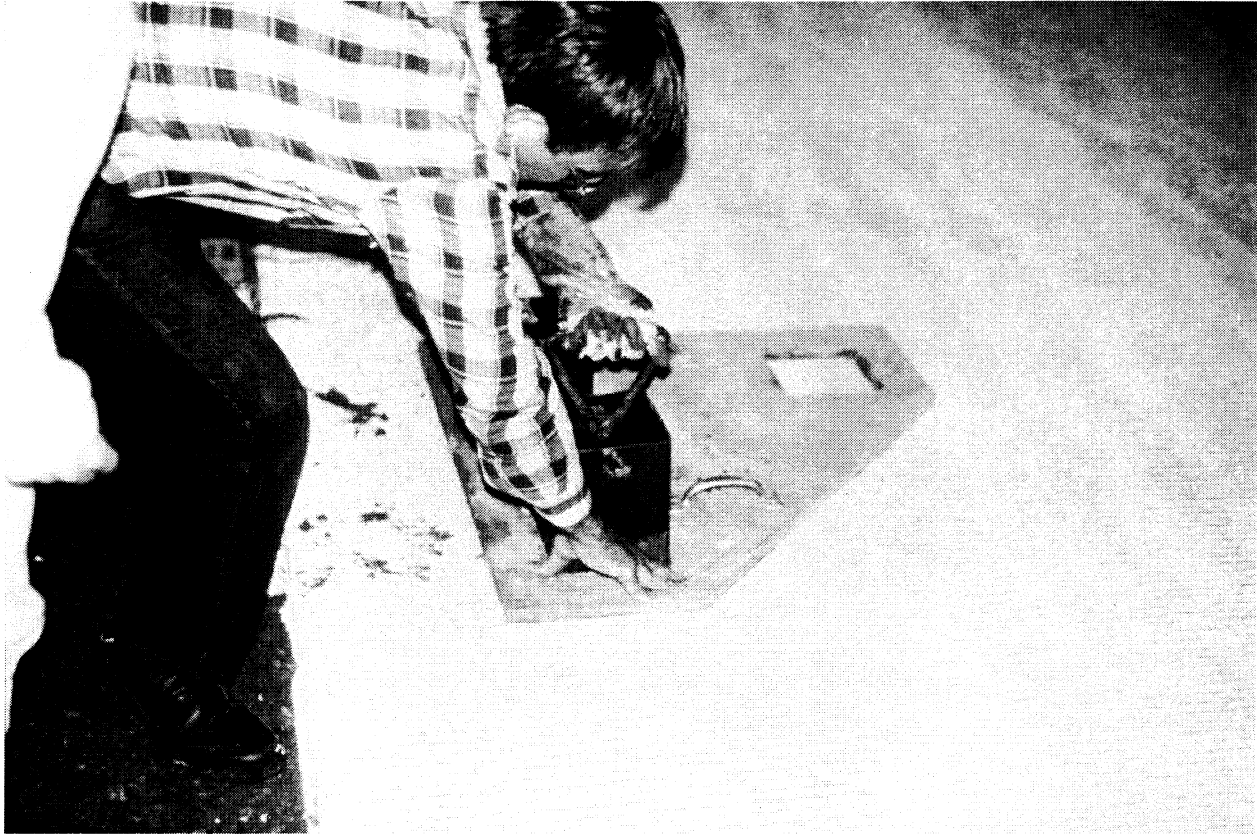
Figure 13 Pulse Velocity Test Tube Extraction

The form tubing was removed by extracting it vertically as shown in Figure 13. A custom built handle was inserted into holes near the top of the tubing on opposite sides. This method worked very well when the tubing was well oiled prior to insertion and pulled vertically after the concrete was removed. The result was a four sided, smooth walled hole that provided good contact for the transducers.

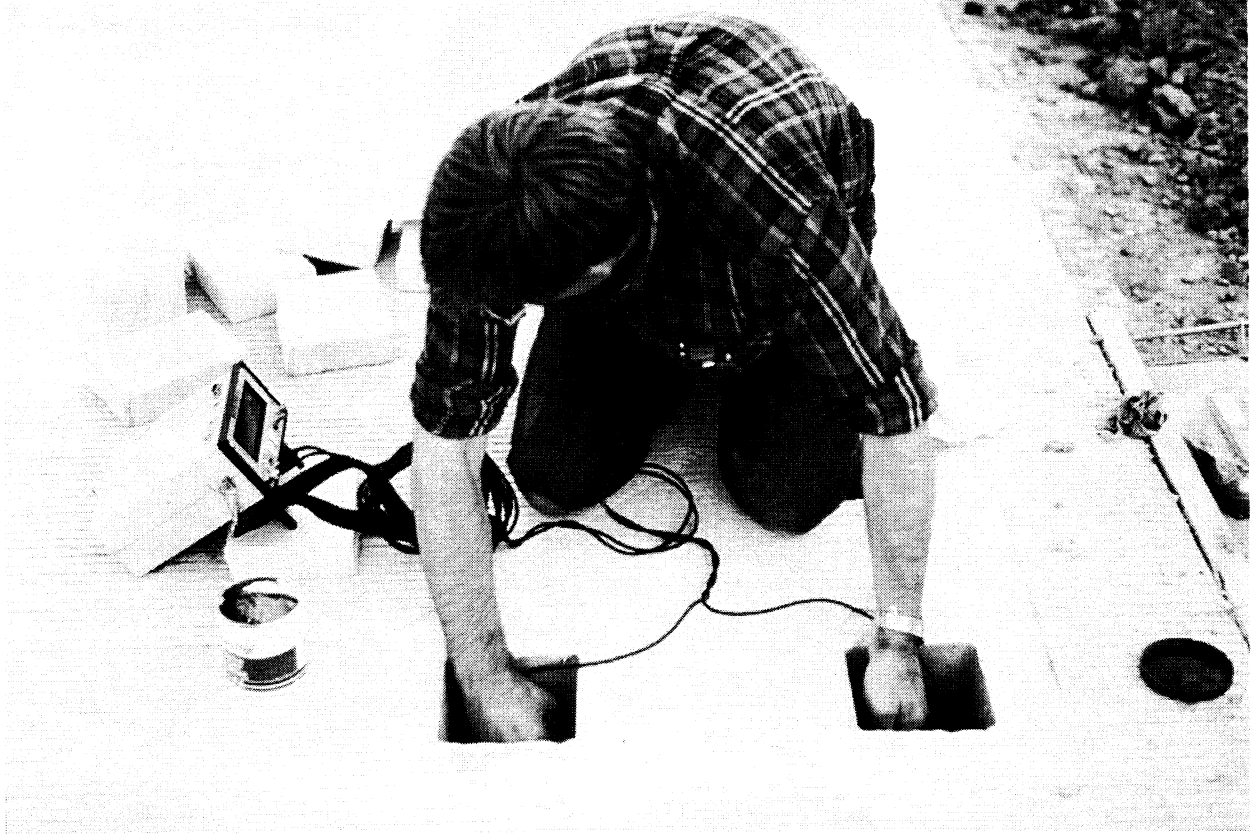
Figure 14, Pulse Velocity Measurement Activity

Pulse velocity measurements were taken by attaching the two geophones to the readout device, greasing the geophone heads and positioning them in two adjacent holes with the heads pointing at each other. The grease served to make an airtight contact with sidewall of the hole and prevent adhesion of the concrete with the device. This test is illustrated in Figure 14. Note the presence of insulation blocks on the pavement. These were inserted in the access holes during the time between pulse readings to assure the retention of temperature and moisture in the walls of the access holes. Upon completion of the pulse

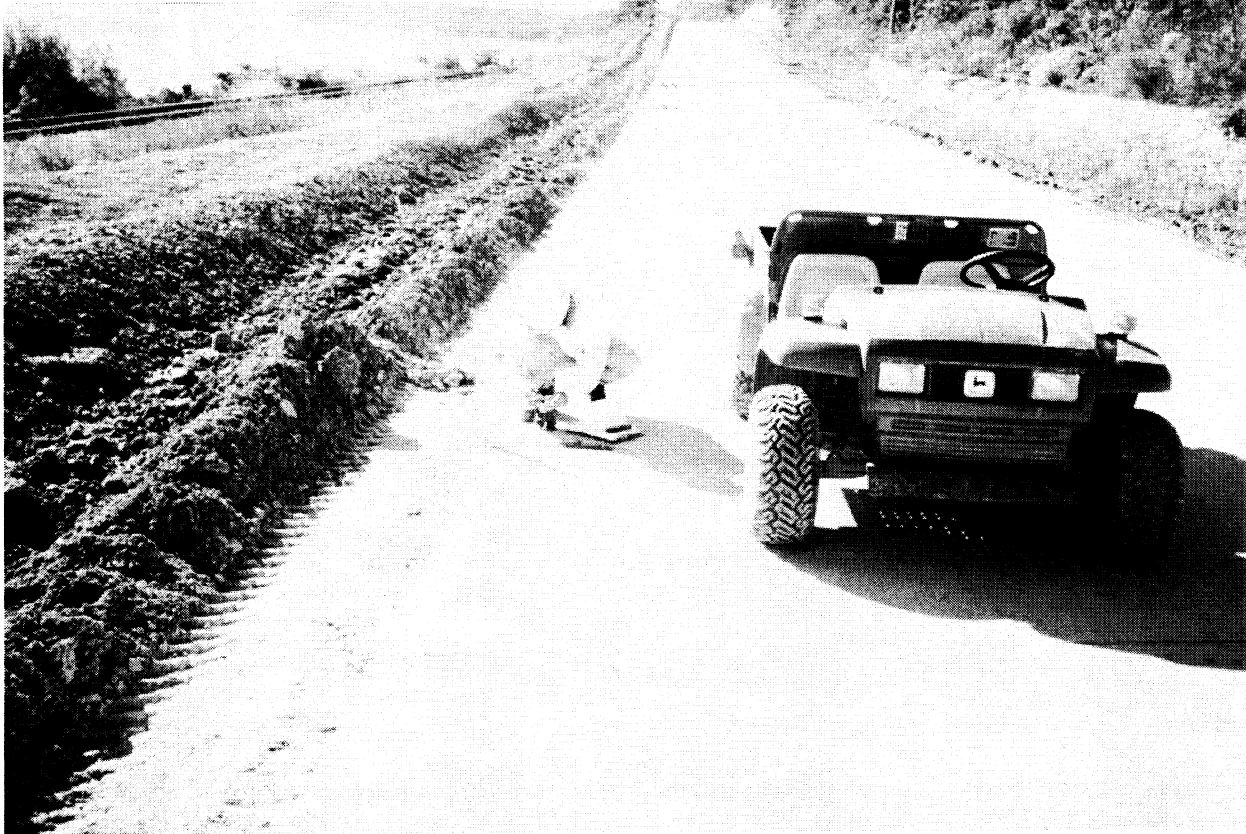
Figure 20, Data Collection Vehicle

The speed of paving and the accessibility to various parts of the project did make data collection more difficult. The lack of access roads at the end of each mile and the narrow shoulders did not allow for full size vehicles to traverse the project during concrete curing. The research team was able to minimize the problem with the rental of a small four wheel drive vehicle to navigate the shoulders and new pavement area prior to full vehicle access. A John Deere "Gator", shown in Figure 20 was found to be very helpful to the research team and county

personnel for movement of testing equipment and supplies along the length of the project. It allowed for collection of large amounts of maturity data in small amounts of time.
